New P filter demo site at Fensholt in Denmark

P losses in DK

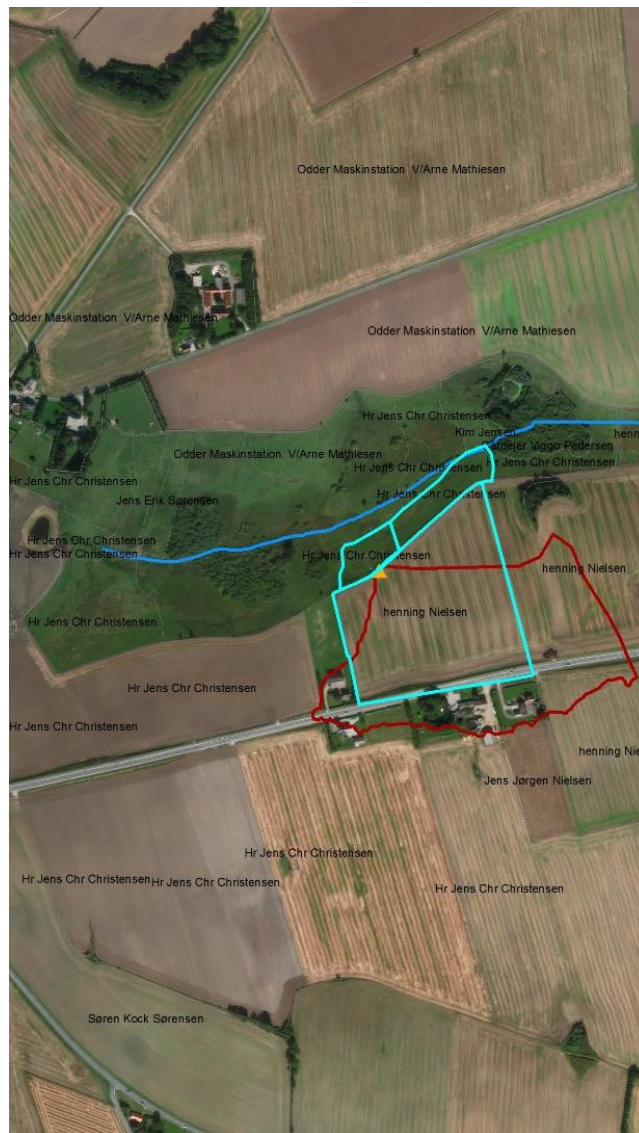
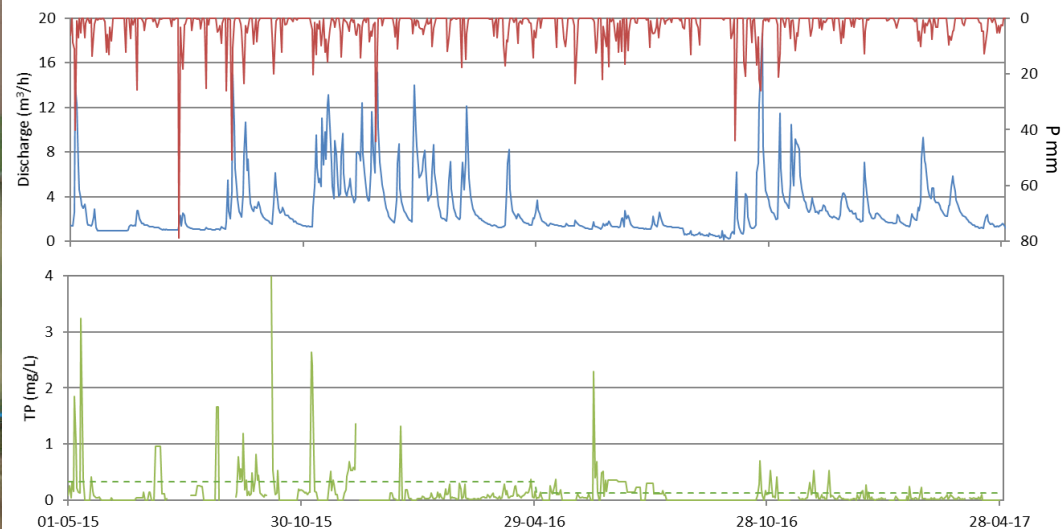
May 2015/16	Catchment area (ha)	8.4
	P (mm)	349
	Q/P (-)	0.30
	TP (kg/ha)	1.1
	Flow weighted average TP (mg/L)	0.32
May 2016/17	P (mm)	246
	Q/P (-)	0.28
	TP (kg/ha)	0.3
	Flow weighted average TP (mg/L)	0.13
