Co-analysis for the Mariakerke (Belgium) nourishment site

Sebastian Dan¹ and Daphne Thoon²

¹Flanders Hydraulics Research, Berchemlei 113-115, 2140 Antwerp, Belgium
²Agency for Maritime and Coastal Services, Coastal Division, Vrijhavenstraat 3, 8400 Ostend, Belgium

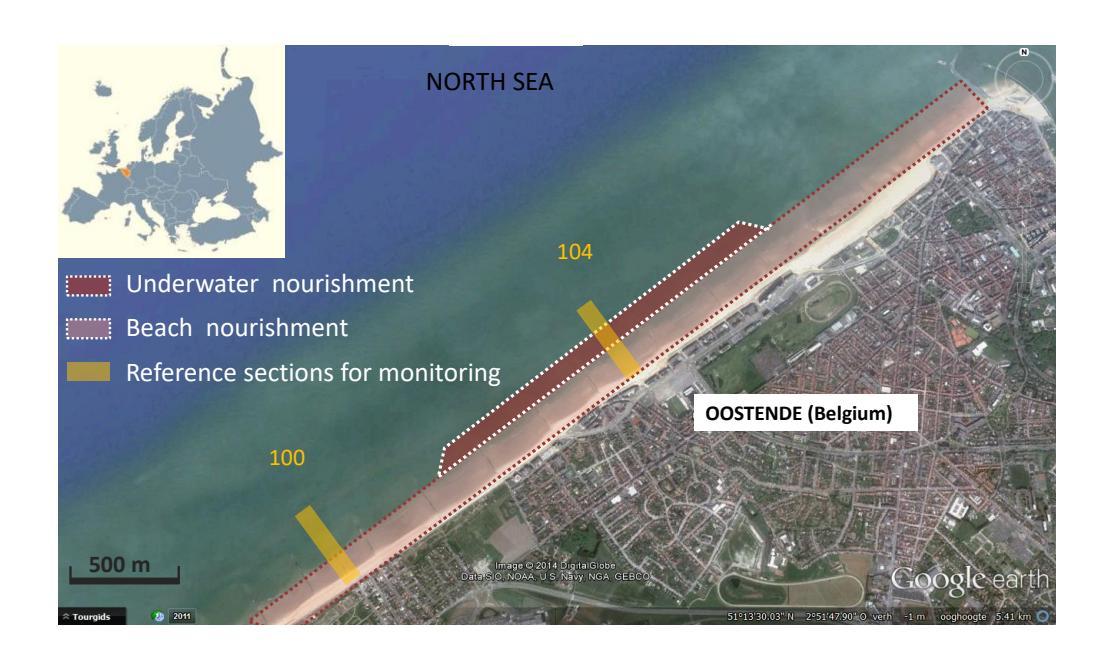
Figure 1 - Pilot site for shoreface nourishment experiment, Mariakerke coastal area, and the reference sections 100 and 104.

Safety against storm induced flooding at the Belgian coast is one of the most important topics for the local coastal management. Historically, hard constructions were buildt for coastal protection, but in the present decades soft methods such as nourishments are preferred. The large majority of the nourishments were carried out on the intertidal and dry beach. This method is very efficient to reduce wave overtopping but is more costly than shoreface nourishments and has a greater impact on the use of the beach while being carried out. Therefore shoreface nourishment was suggested as possible alternative. This method would still preserve the safety function by assuring a sufficient volume of sand in the nearshore area, but at significantly lower costs and less disturbance at the coast. At the area Mariakerke – Raversijde ¹(just SW from Ostend harbour, Figure 1) a nourishment experiment was designed to observe the behaviour of the coast when nourished just on the dry and intertidal beach (Section 100, Raversijde, see figure below) compared to the coast nourished on both beach and shoreface (Section 104, Mariakerke).

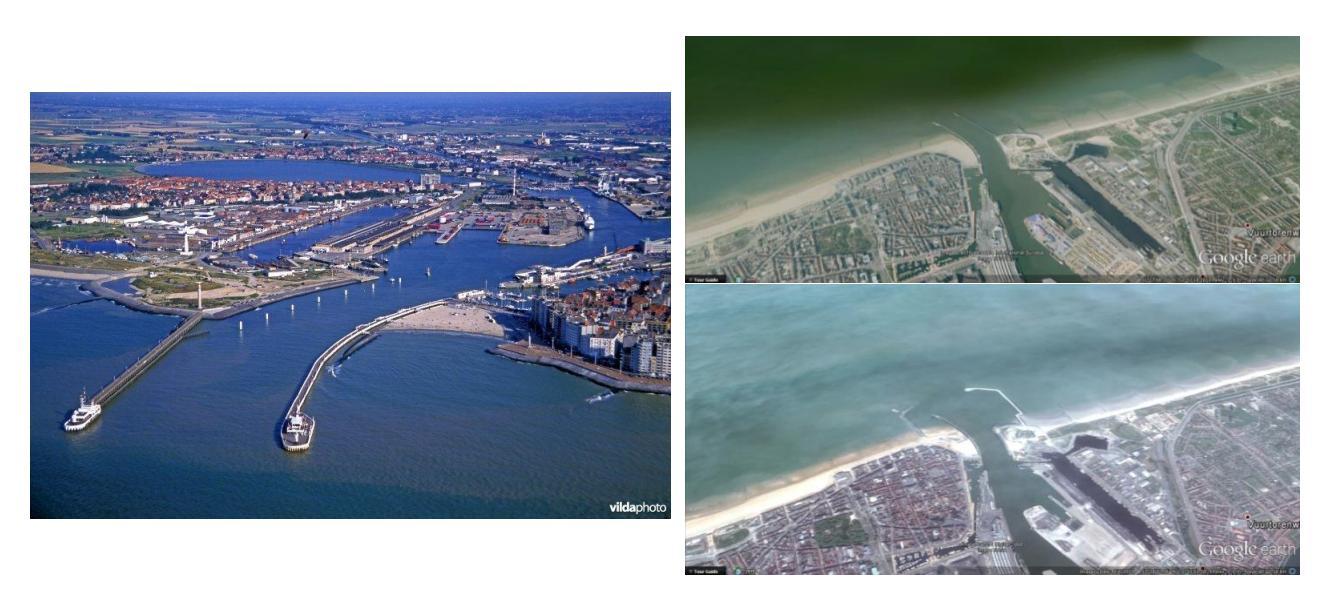
Figure 1 – Ostend harbor overview before 2004 (INSHORE, left), in 2007 (GoogleEarth, right top) and in 2011 (GoogleEarth, right bottom).

Before 2004, the beach in Ostend center consisted of a narrow strip in low tide and no beach at all at high tide. The emergency nourishment raised the beach profile, so that at high tide, a strip of about 200 m of dry beach was created. The nourishment took place between April and June 2004. The median grain size before nourishment was about 0.2mm and after nourishment 0.3-0.35mm, locally up to 0.4mm (Bertels et al., 2012).

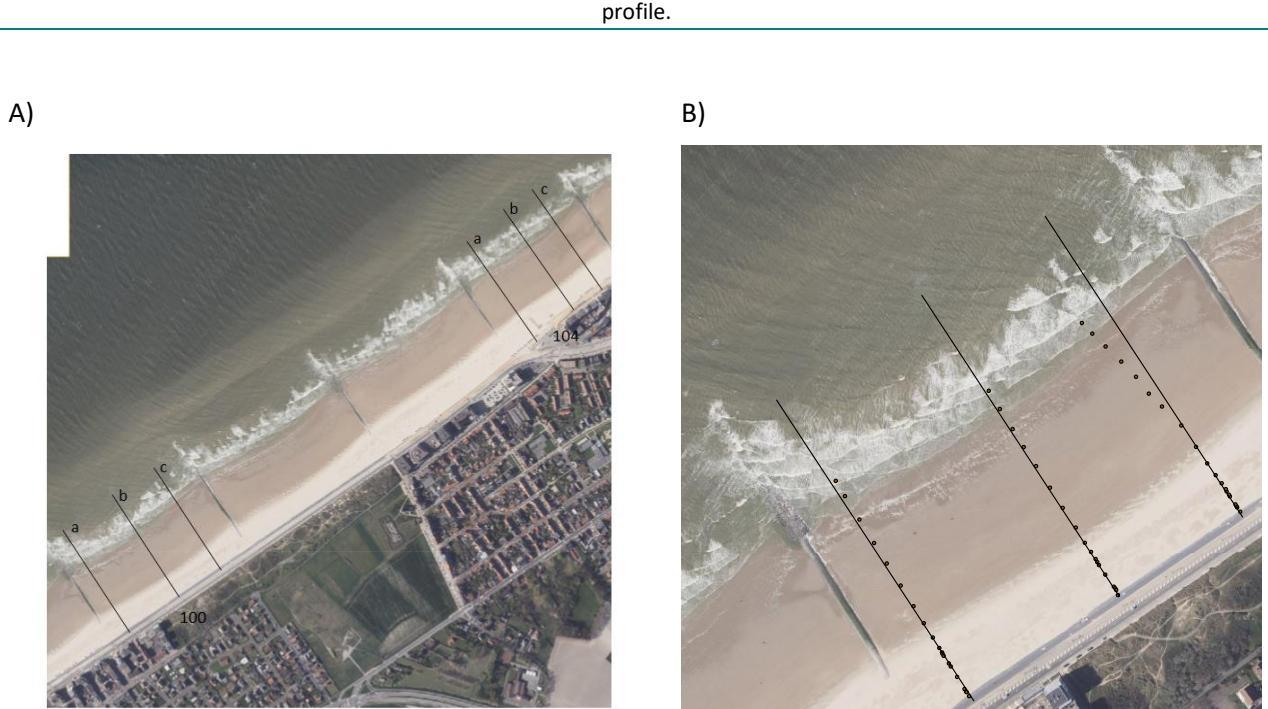
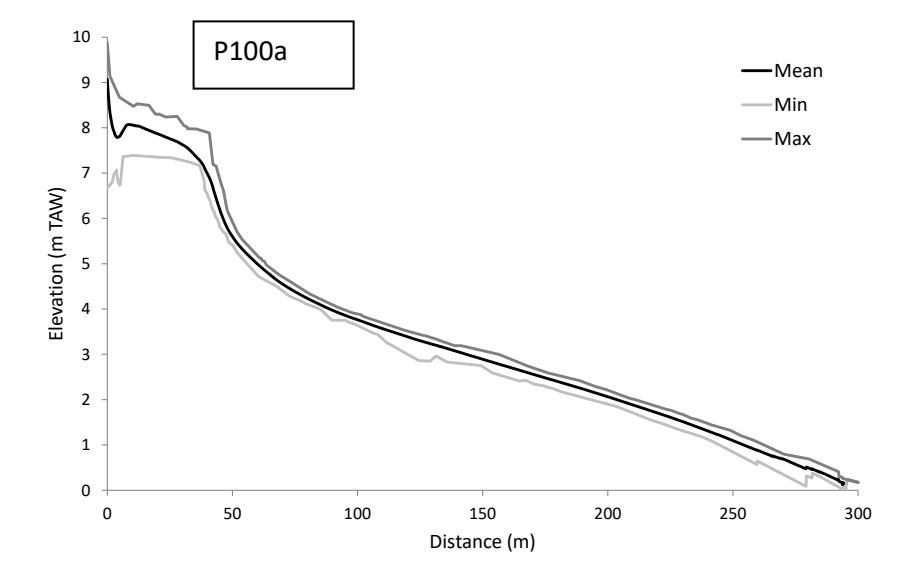
Figure 7 – Envelope of the cross-shore profiles for section P100 (a, b, c) at Raversijde-East from September 2015 to December 2017.

Figure 7 and Figure 8 show the envelope of the three re-projected cross-shore profiles for section 100 (a,b,c) at Raversijde-East and section 104 (a,b,c) at Mariakerke from September 2015 to December 2017. Both sections indicate the presence of a berm of the dry beach above +7.0 m TAW while the intertidal beach is with featureless and a gentle slope. The greatest elevation variability is found on the upper beach at a distance of less than 50 m from the dyke while the changes of the intertidal beach are usually minor (except

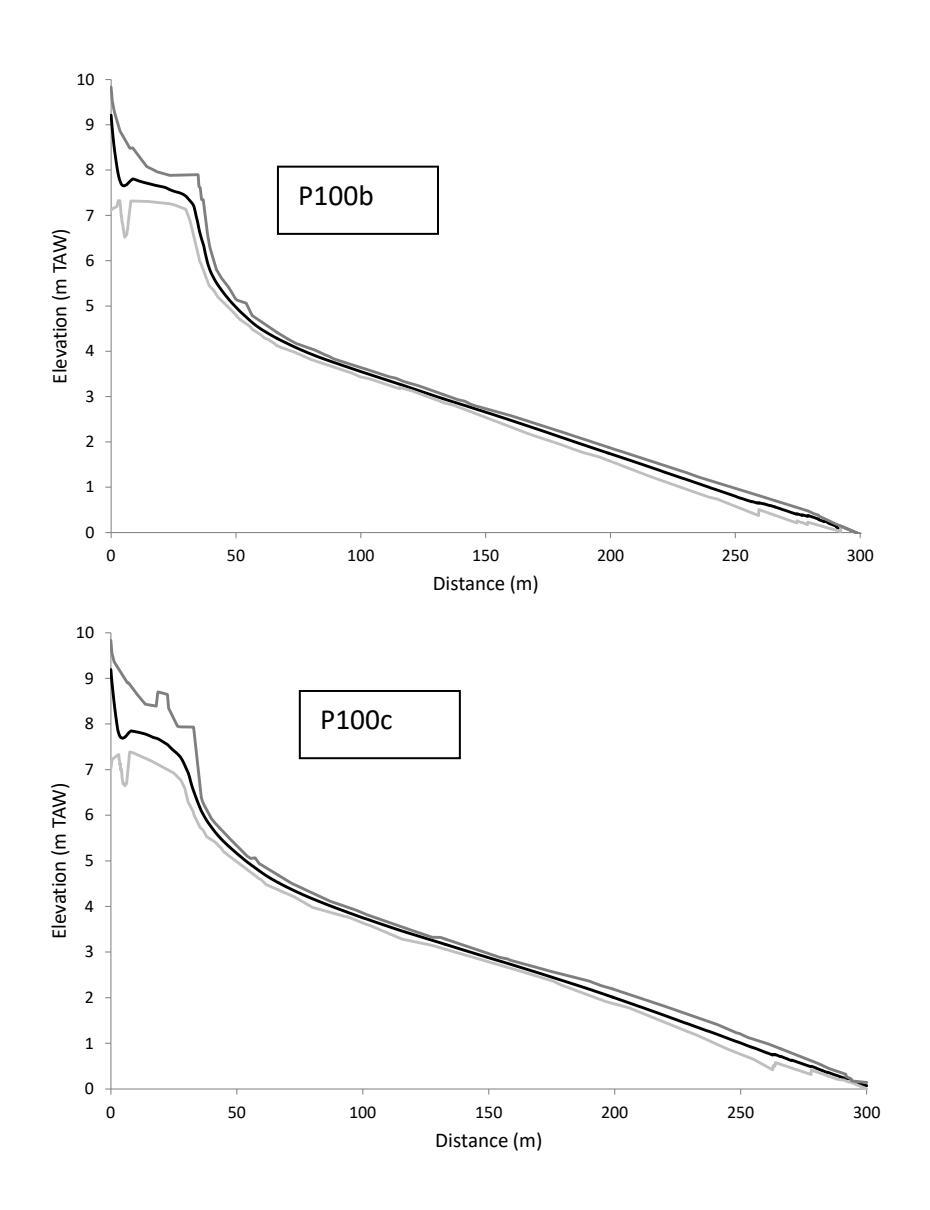
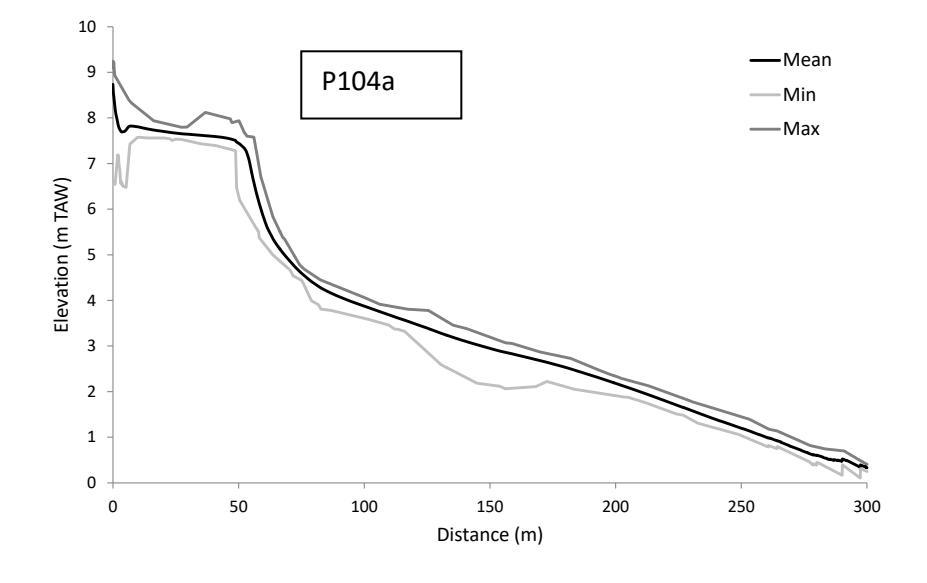
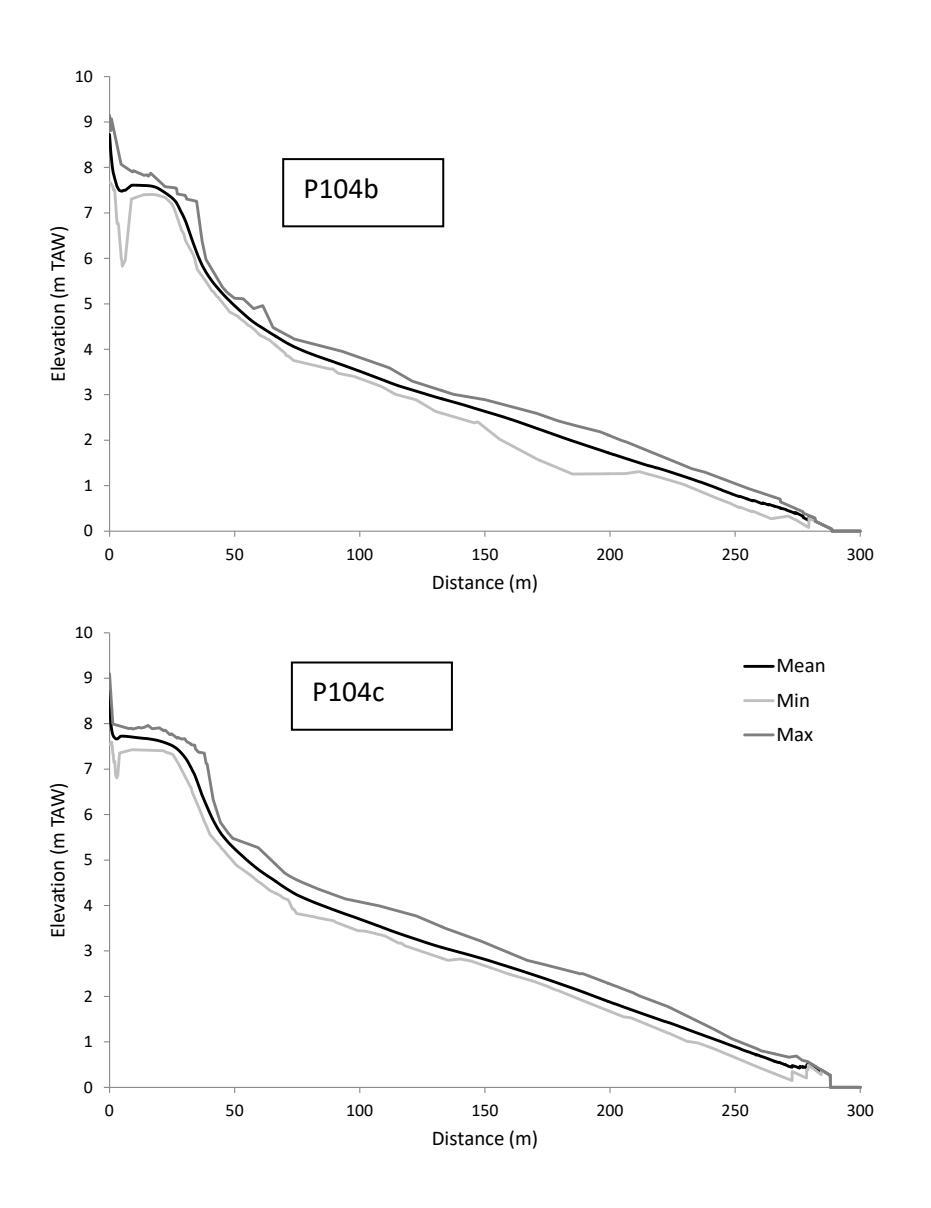
Figure 8 – Envelope of the cross-shore profiles for section P104 (a, b, c) at Mariakerke from September 2015 to December 2017.

for profile P104a and P104b). Thus, a spatial and temporal variability of the elevation is observed at a monthly scale. As expected at location 104 were more both types of nourishments were performed the variations are larger than at location 100.

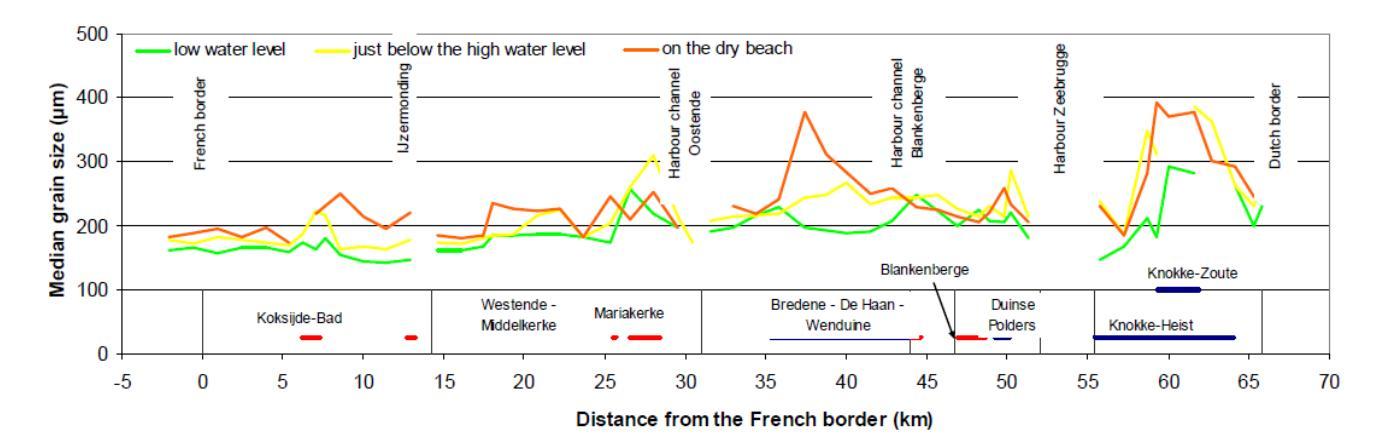
Figure 10 – Longshore variation of the median grain size for three positions on the beach (after Deronde, 2007).

Deronde (2007) presented the median grain size for three cross-shore positions on the beach: at the low water level, just below the high water level, and on the dry beach based on the analysis of 357 samples collected on the Belgian beach in the years 2001 and 2002 (Figure 10). The areas where beach nourishment (e.g. Knokke-Zoute) or beach scraping (e.g. Mariakerke) at that time are indicated in red and blue, respectively. The figure shows a clear trend of the increase in grain size along the Belgian coast from the southwest (French border) to northeast (Dutch border), ranging from 170 µm to about 400 µm in De Haan

and Knokke-Zoute. There is also the trend of increased grain size towards the dry beach. At Mariakerke, most of the samples show the median grain size in the range of $170-250 \mu m$.
