22/02441

# Change detection on shipwrecks using synthetic aperture sonar

– North Sea Wrecks Task 3.5 Deep Water Case Study

Roy Edgar Hansen

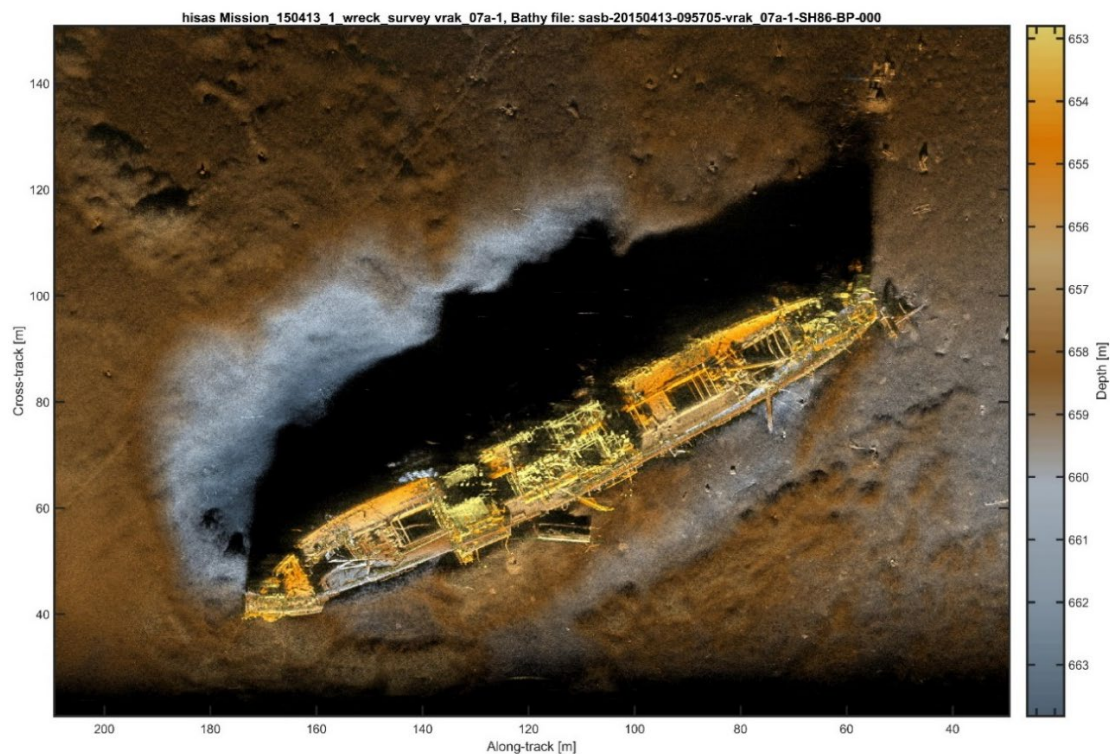
Figure 2.1 Fusion of SAS image and bathymetry of wreck 07 in the Skagerrak WWII dumpsite.

Figure 2.1 show an example SAS image fusioned with SAS bathymetry of wreck 07 in the Skagerrak WWII dumpsite (Sæbø and Lorentzen 2016). The fusion technique is described in Hansen et al. (2017). The image resolution is approximately 3x3 cm before despeckling and 9x9 cm after despeckling (Austeng et al. 2013). The bathymetric resolution is 18x18 cm. The shipwreck is more than 130 m long, intact and placed standing on the seabed. Most of the cargo is therefore believed to still be inside the shipwreck.

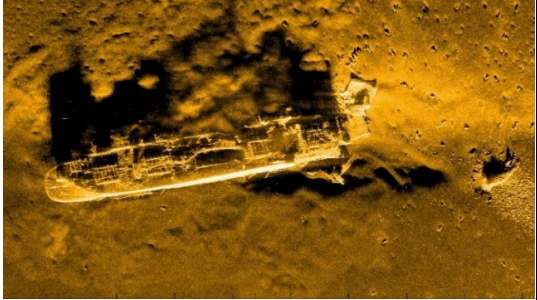
| <p><b>SAS image</b><br/>2D representation of the relative acoustic reflectivity. The choice of render plane is critical for the information content and correctness of the data. The image has higher resolution than the map. Shadowing, layover and multiple scattering cause potential false echoes that may be misinterpreted as changes.</p> | |

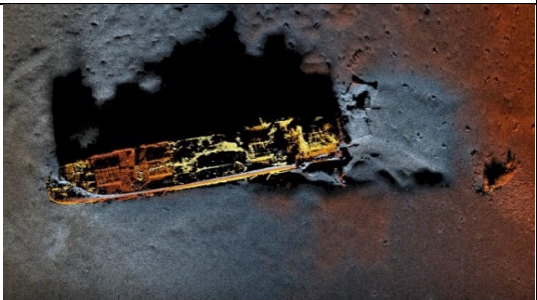
| <p><b>SAS bathymetry in 2D</b><br/>Seabed depth measured in a 2D grid combined with the SAS image and the SAS coherence. As for the image, layover and multiple scattering complicates the use of the data. Coherence values below a threshold leads to disqualification of the data.</p> | |
